RCRA Compliance Inspection Report

U.S. Department of Energy Hanford

400 Area, 242A Evaporator Unit, WSCF Laboratory

May 19-21, 2014

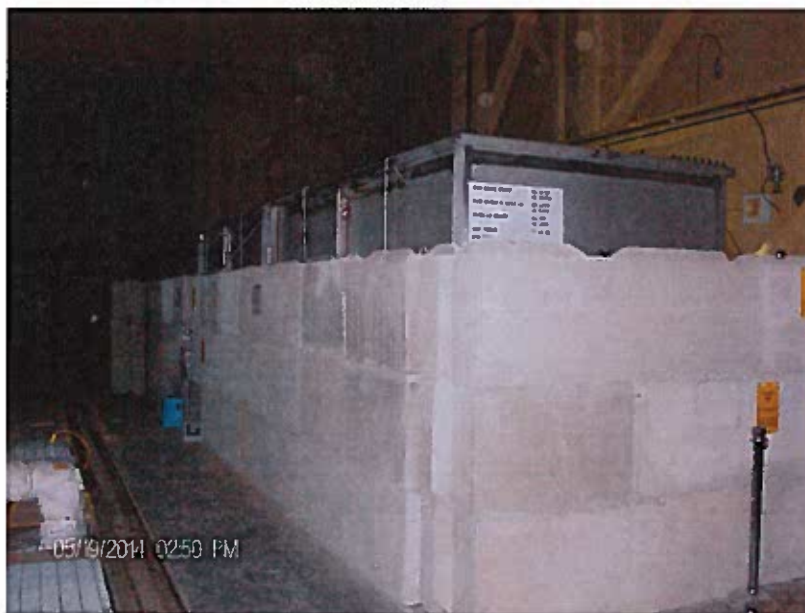
- ISA - 19 drums of mixed waste (one contained sodium potassium (NaK));
- FSF - two large metal boxes containing approximately 100 tubes, ten feet long, each holding 2.5 gallon thimbles containing two gallons of sodium metal mixed waste in an argon atmosphere. The two metal boxes were surrounded by thick concrete blocks to provide shielding from radiation (see Photo HPIM4813 below);

Photo HPIM4813 Large containers of alkali mixed waste in FSF

3. HPIM4813 - Overview of two large containers with alkali mixed wastes within concrete walls in the 400 Area Fuel FSF building.
4. HPIM4814 - Another view of the two large containers with alkali mixed wastes within concrete walls showing hazardous waste labels in the 400 Area FSF building.

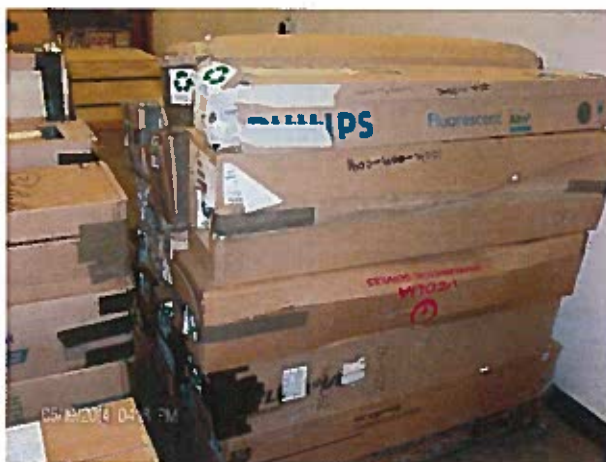
Also, at the CCRC we observed a box of fluorescent lamps that was labeled universal waste lamps. The box was only partially closed on one end by tape so that the ends of some lamps were visible (see photo HPIM4825 below).

Photo HPIM4825 Open container of universal waste lamp at the CCRC

15. HPIM4825 - A closer view of boxes of spent lamps managed as universal wastes that were not closed due to open hand holds or extending beyond the end of the box in Bldg. 4734B CCRC.

Containers holding of universal waste lamps must be structurally sound and remain closed. We also observed at least one box that contained florescent lamps that was labeled indicating the contents were universal waste lamps. The box had a large hole in its side. Large quantity handlers of universal waste accumulate lamps in containers or packages that are structurally sound and must lack evidence of damage that could cause leakage under reasonably foreseeable conditions.

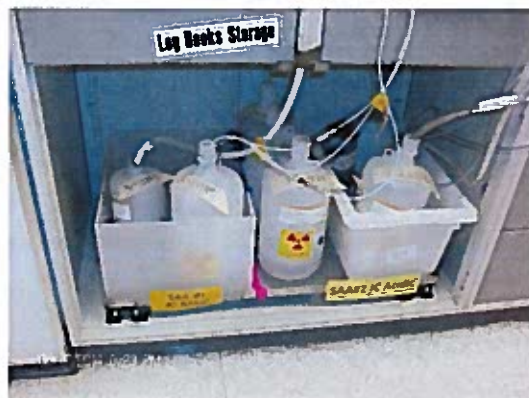
We observed containers being used to collect waste from analytical instruments. Ms. Meyers stated that the waste is characteristic for either metals or solvents depending on the analysis that is being run. She further stated that they are managed as satellite accumulation areas (see photo HPIM4829 below). We noted that the containers were open and it was not clear whether the instruments were operating or if waste was being added to the containers. Following the inspection we received a letter by email from Mr. Mills confirming that the instruments were operating at the time of the inspection and waste was being added to the containers.

Photo HPIM4829 Open satellite accumulation containers in WSCF lab

18. HPIM4829 - View of open containers that were connected to instruments with hoses for accumulating wastes managed as a SAA in Rm. N3 in the Waste Sampling and Characterization Facility (WSCF).

I expressed concerns regarding the open universal lamp containers and the open satellite accumulation containers at WSCF.
